ERROR CODES

Error No. 53

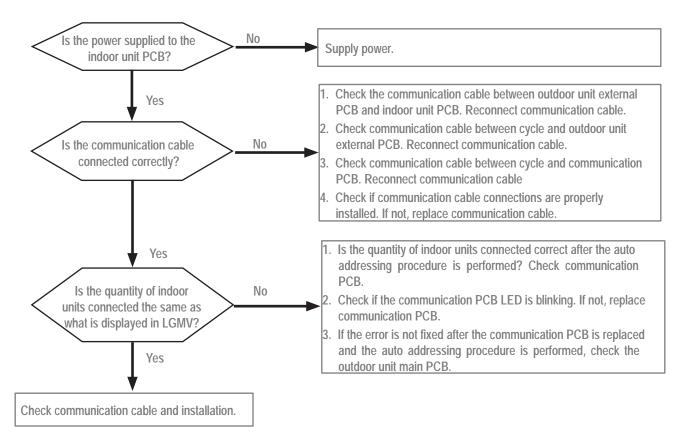
Error No. Description		Details	Causes	
53 Master: 531 Slave 1: 532 Slave 2: 533	Communication error between outdoor unit main PCB and indoor unit (s) PCB.	Outdoor unit main PCB cannot receive the signal from the indoor unit.	 Communication cables are not connected between external PCB and indoor PCB. Communications cables are disconnected or have short circuited between the main PCB and external PCB. Communication cables are disconnected or have short circuited between the main PCB and communication PCB. Communication cables are disconnected or have short circuited (communication cable connection error.) Power to the indoor PCB is off. Defective outdoor unit main PCB, communication PCB, and / or indoor unit PCB. Outdoor unit main PCB / indoor unit PCB is defective or damaged.

Error No. 53 indicates there is a communication error between the outdoor unit and indoor unit(s). See LGMV to help determine which indoor unit or units are not communicating with the outdoor unit.

- Does LGMV display the correct number of indoor units? If LGMV DOES NOT display the correct number of indoor units, find the missing indoor unit or units and troubleshoot.
- If LGMV DOES displays the correct number of indoor units, but the outdoor unit still shows CH53, check the communication count line on LGMV. Find the indoor unit that does not have a communication count increase—that indicates the indoor unit which is not communicating. The indoor unit may have:
- 1. Wrong communication cable or power wiring connection(s).
- 2. A PCB malfunction.
- 3. Duplicate address numbers for indoor units (Error No. 53 will appear at the indoor unit).
