ERROR CODES

Error No. 26

Error No.	Description	Details	Causes		
26 Master: 261 Slave 1: 262 Slave 2: 263	Outdoor unit inverter compressor operation error.	Inverter compressor start failure.	 Overload error: Piping is clogged, indoor or outdoor unit is blocked, EEV is blocked, or there is an overcharge in refrigerant. Compressor insulation and / or motor has been damaged. Compressor wiring error. Outdoor unit inverter PCB has been damaged (CT).

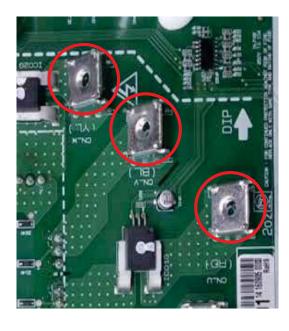
Compressor wiring connections.

Check R(L1) / S(L2) / T(L3) wiring connections.

- 2. Check if the wires have disconnected or were damaged.
- 3. Check compressor terminal connections for bad contacts.
- → Reassemble if errors are found.
